Manhole Inspection Summary

Manhole # S33A__038MH

Insp Date: **5/28/09 2:07 PM**

Location Address: **205 W CENTRE ST**

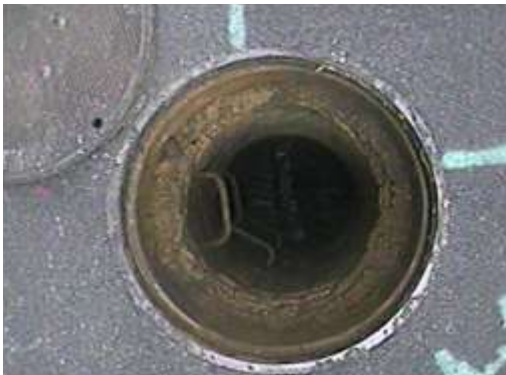
Defect 1

loose bricks frame adjustment and frame offset

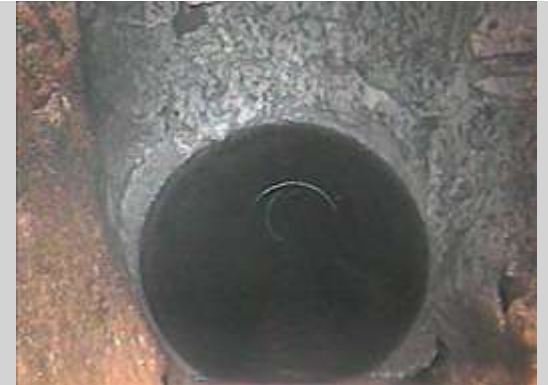
12 O'Clock Outflow

8 in. Circular Gravity Sewer
Pipe Out @ 12 O'Clock

Infiltration: **None** Pipe Seal Cond: **Sound**

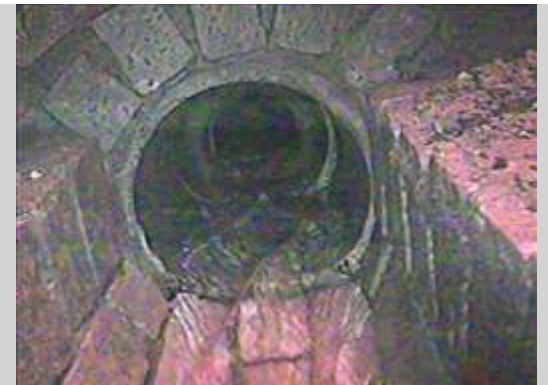
3 O'Clock Inflow

6 in. Circular Gravity Sewer
Pipe In @ 3 O'Clock

Infiltration: **None** Pipe Seal Cond: **Sound**

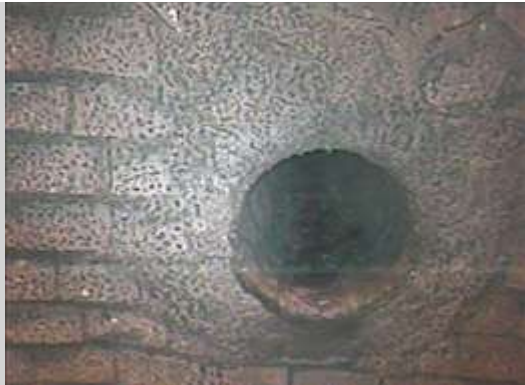
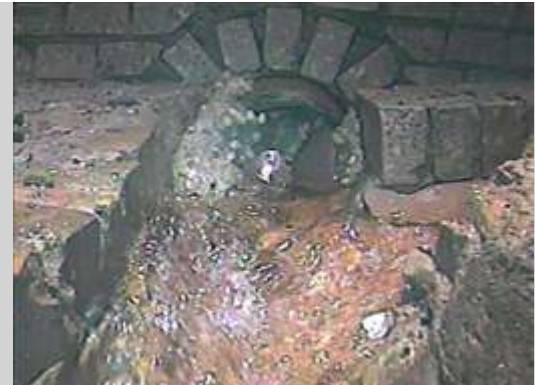
6 O'Clock Inflow

8 in. Circular Gravity Sewer

Pipe In @ 6 O'Clock

Drop In @ 6 O'Clock

Infiltration: **None** Pipe Seal Cond: **Sound**

Drop: **Inside** **Direct**

Drop Condition: **Open**
